DOYLE ZENITH VERTICAL BATTEN FURLING MAINSAIL

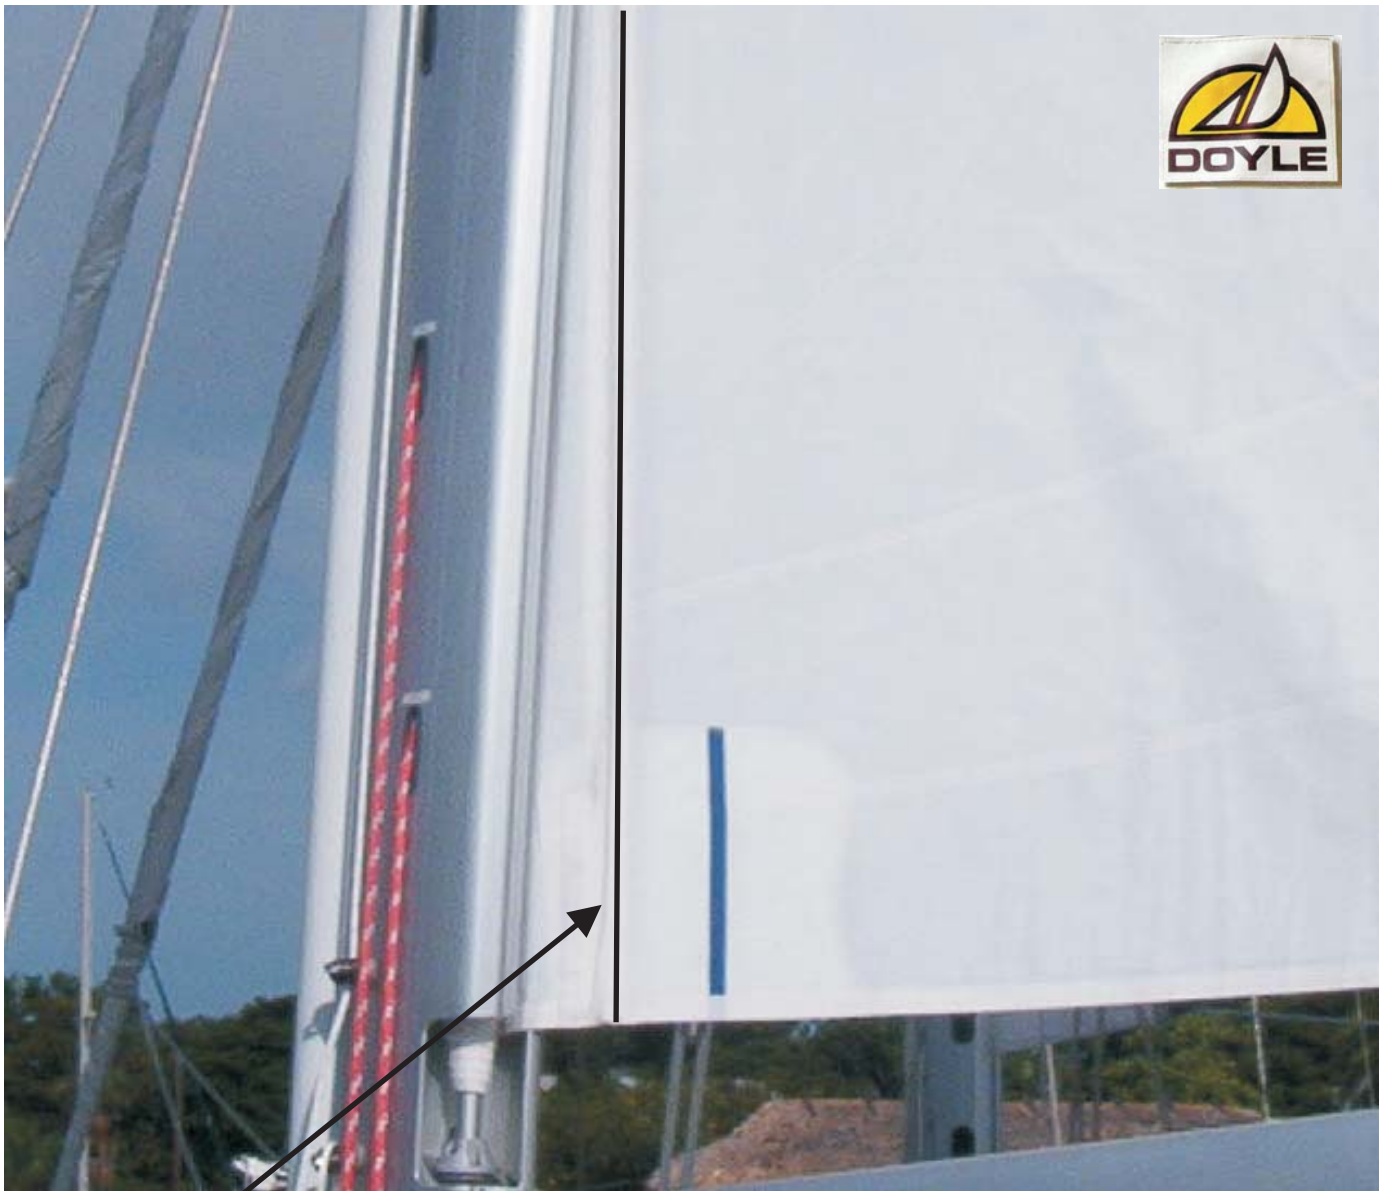
Bottom of Batten going in after top

This is usually a result of the foot being tight and the leech being loose when furling. In this scenario, the upper portion of the sail will furl more loosely causing the Leech of the sail to enter the mast before the Foot.

In this situation, try tightening the vang and/or main sheet, and/or lowering the topping lift in order to even the tension between the Foot and Leech when furling.

This will allow the sail to roll in evenly, and tightly avoiding any possible sail overrides and or binding when unrolling

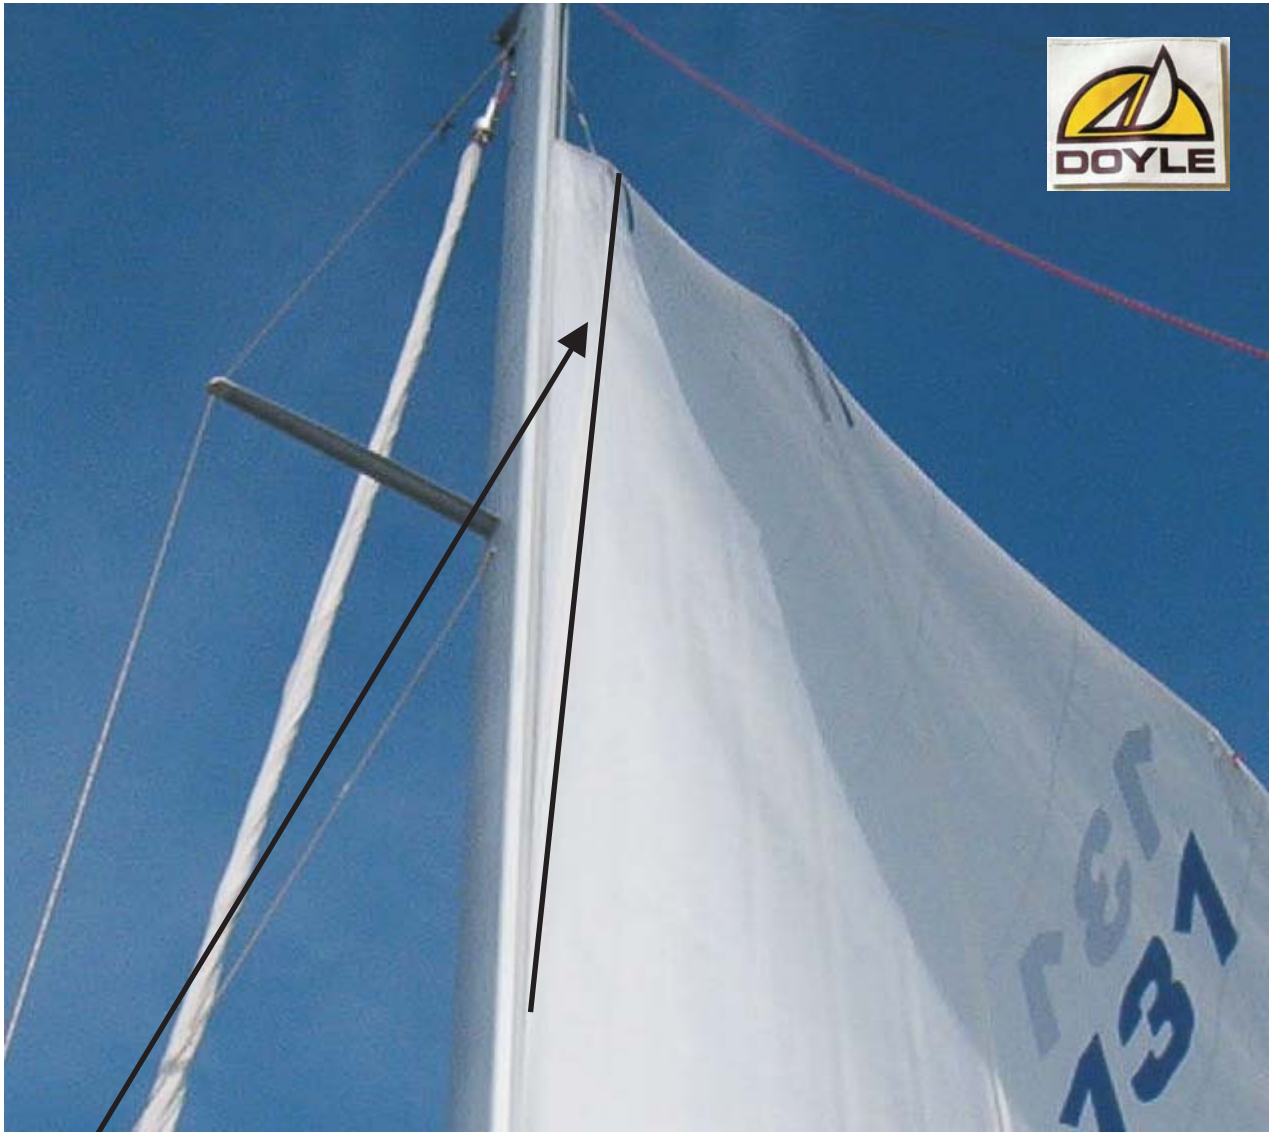
Top of Batten going in after bottom

This is usually a result of the Leech being tight and the Foot being loose when furling. In this scenario, the Lower portion of the sail will furl more loosely causing the Foot of the sail to enter the mast before the Leech.

In this situation, try easing the vang and/or main sheet, and/or raising the topping lift in order to even the tension between the Foot and Leech when furling.

This will allow the sail to roll in evenly, and tightly avoiding any possible sail overrides and or binding when unrolling

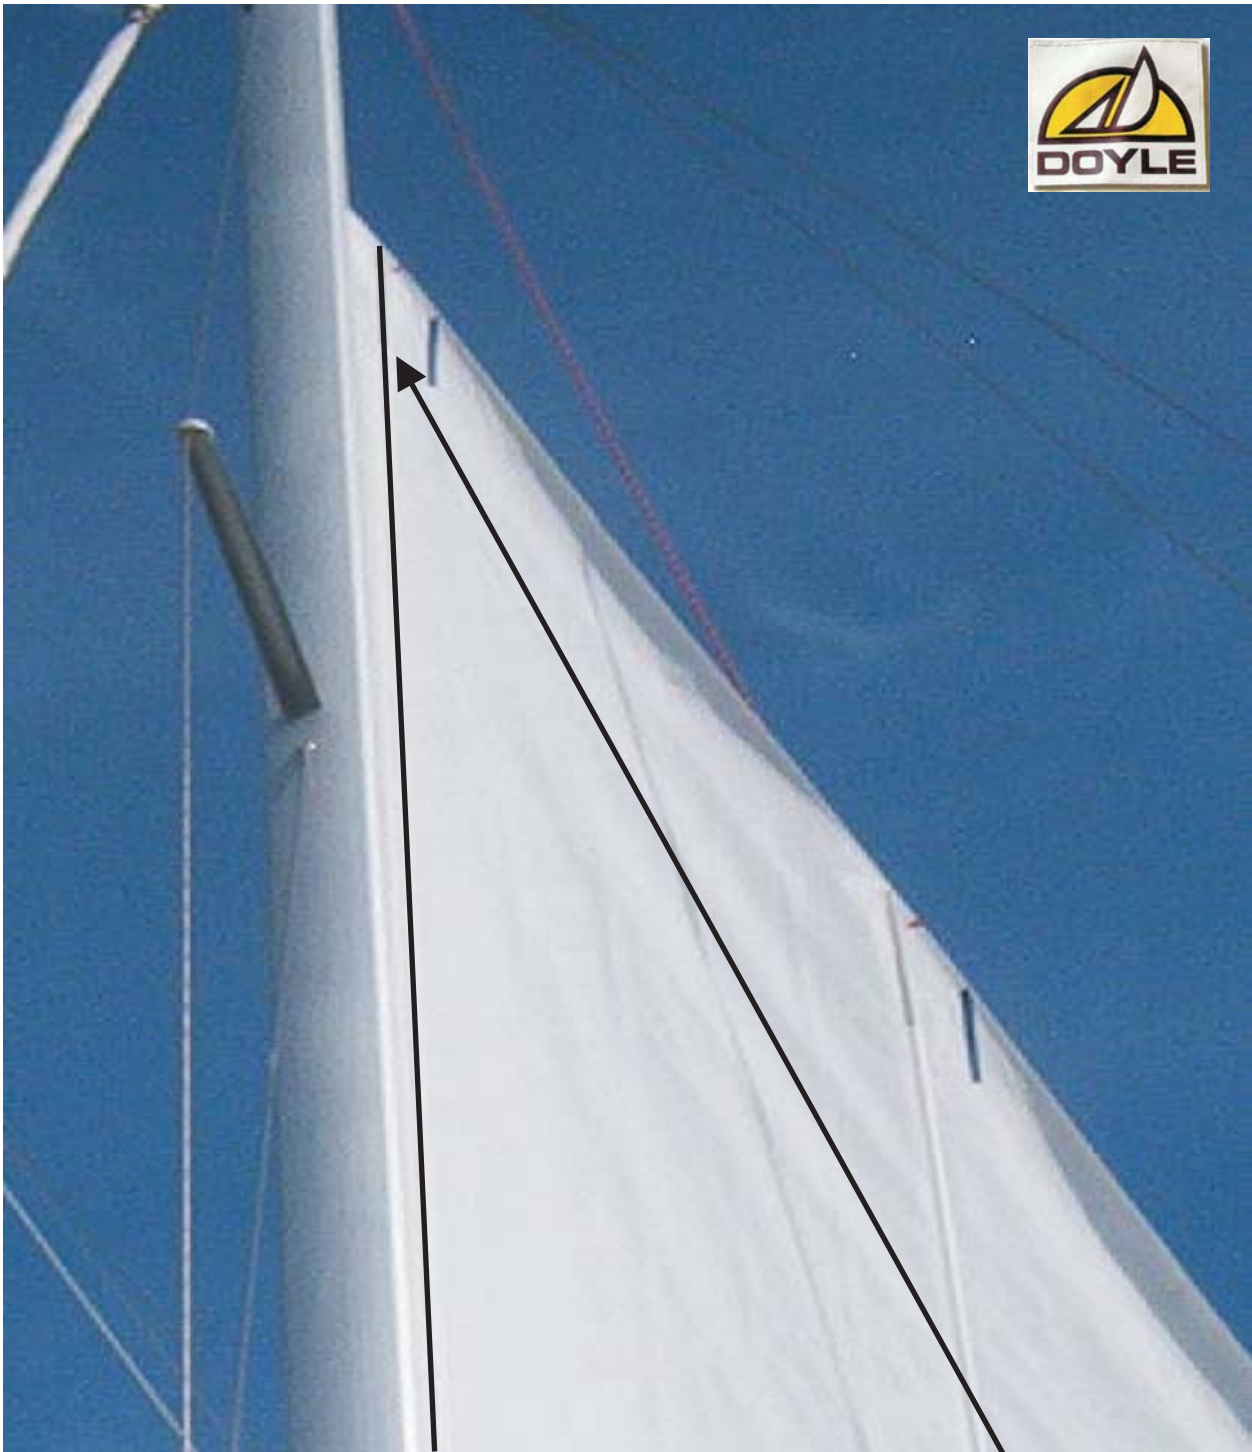
Batten going in at acceptable angle.

2-4 inches difference between the top and bottom is acceptable. If more than that, roll out and try again. Boom attitude (up or down) and even tension on the Foot and leech is the Key

Preferably, on a calm day and at the dock, *spend some time rolling and un-rolling your sail* to get a better feeling of tension required, as well as vang and topping lift settings.

If Top of batten goes in ahead of bottom, try lowering boom end.

If Bottom of batten goes in ahead of Top, try raising boom end.
